A CASE STUDY OF AIRCRAFT COMPOSITE COMPONENT REPAIR UTILIZING AUTOCLAVE CURING

Abstract: This paper presents the evaluation process of aircraft composite component structural repair of flap fairing origin for Boeing 737-800 aircraft. The intended repair has been carried out due to a wide area of damage that requires utilization of an autoclave. All preparations are carried out in accordance to the aircraft structural repair manual of Boeing 737-800 aircraft. The damage is removed via the step cutting method on the outer surface of the component prior to the inspection verification via tap test inspection. In order to prevent profile bending and torsion, the part is placed on a male mold that will be vacuumed together. The damaged area is repaired using similar materials and orientation, but with an additional layer as per prescribed in the manual. The component is then cured inside the autoclave at 121°C for two hours at a pressure of four bars. Once cured, the component is inspected through the post-repair inspection for visual and structural integrity prior to painting. The post-repair inspection has indicated that the repair has preserved the component and it is now fit to be u

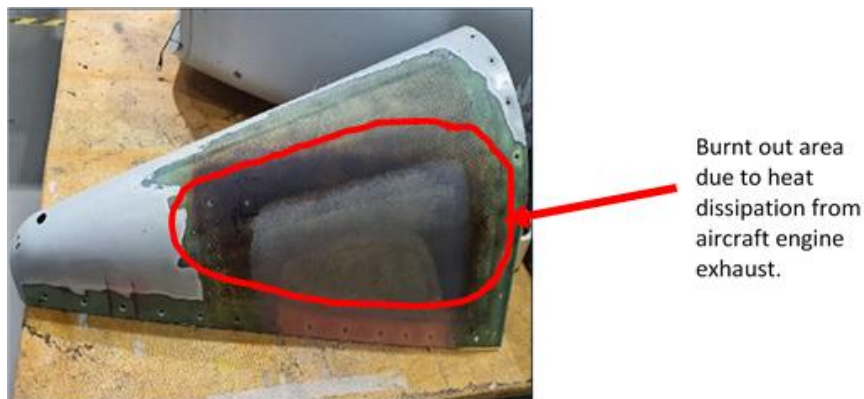
Upon inspecting the IFFF component, it has been found that the inboard side of the component is affected by heat damage due to its close vicinity of the exhaust area. The prolonged exposure has led to diminishing the component integrity and thus it is required to be repaired. Therefore, the objective of the task is to carry out the repair as outlined by Aircraft Structural Repair Manual (SRM) requirement. This involves utilization of the autoclave as the curing mechanism and the comparison of the outcome of curing with respect to the post-repair inspection. In short, the damage is evaluated in accordance to the corresponding SRM [10] and upon evaluation, the area subjected to damage is found to be repairable as documented in the SRM. Damage due crack has been found at the rear section of the component. It has been suggested that a major repair need to be carried out due to the fiber damage and the damage size. A preliminary evaluation is carried out to determine the extent of the damage through both physical and non-destructive testing. The damaged component is shown in Figure 3.

Figure 3: Extent of damage that is observed on the IFFF component

Furthermore, assessment from non-destructive testing has indicated that the damage is feasible to be repaired. However, due to its size characteristic, autoclave curing has been suggested for the curing of the component. This is to ensure the compaction from the pressure can assist in consolidating the repaired plies and subsequently provide a stronger and intact bonding between the original and repair layers. Further information is retrieved pertaining to related material specification and curing parameter. Figure 4 shows the configuration of the component. Upon investigation, P1 to P10 have been removed in order to go for the preparation process. Once the damaged plies have been removed, a male mold is fabricated using layer of fiberglass laminates saturated with high temperature curing resin in preparation for autoclave curing. Six layers of 400 gsm woven roving fiber glass are used, which lead to an average thickness of approximately 8 mm as depicted in Figure 5. It should be noted that the use of the male mold is to provide a positive pressure and reduce distortion whilst curing.

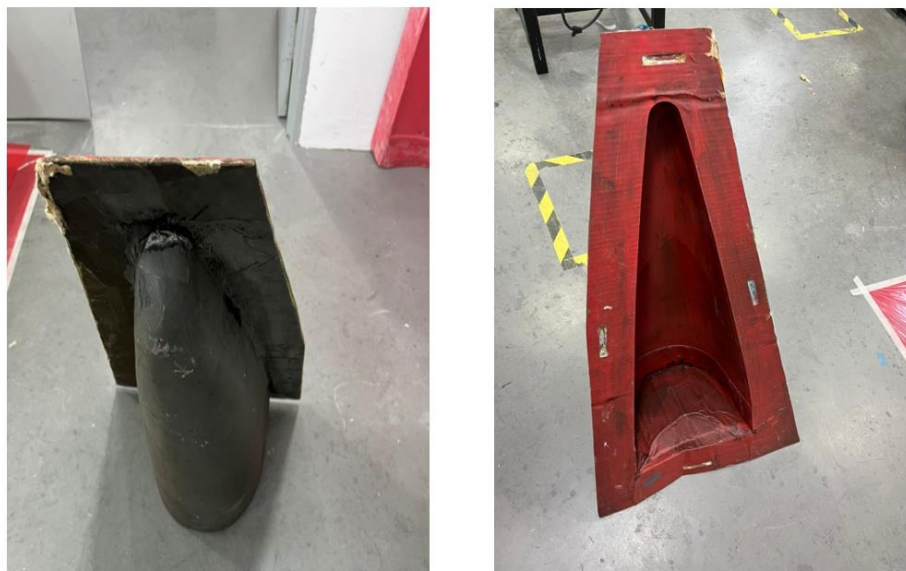
Figure 5: Fabrication of in-house male mold to support the part during curing

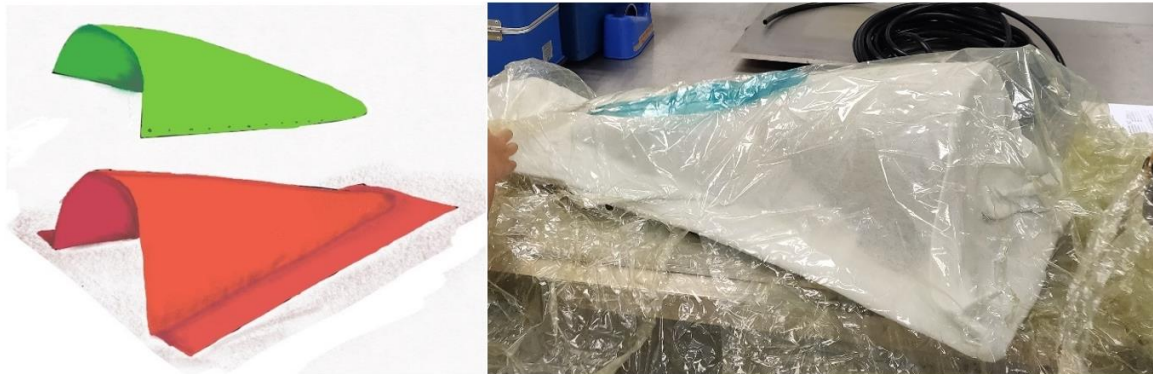
Figure 6: Positioning of the repaired panel on top of the mold and the vacuum bagging encapsulation during curing

of the part during curing, the part has been placed on top of the mold for stabilization. The material of the mold needs to be fabricated by using high temperature resin to suite with the curing environment. This is to ensure that the resin works well with high temperature curing of the part. Figure 6 shows the placement of the part on the mold and the envelope type of vacuum bagging system used to encapsulate the part for curing. The curing has taken place in an autoclave with parameters set accordingly. Prior to curing in the autoclave, the part is vacuumed at 0.75 bar (25 in Hg). After that, the consolidated set up is transported to the autoclave.

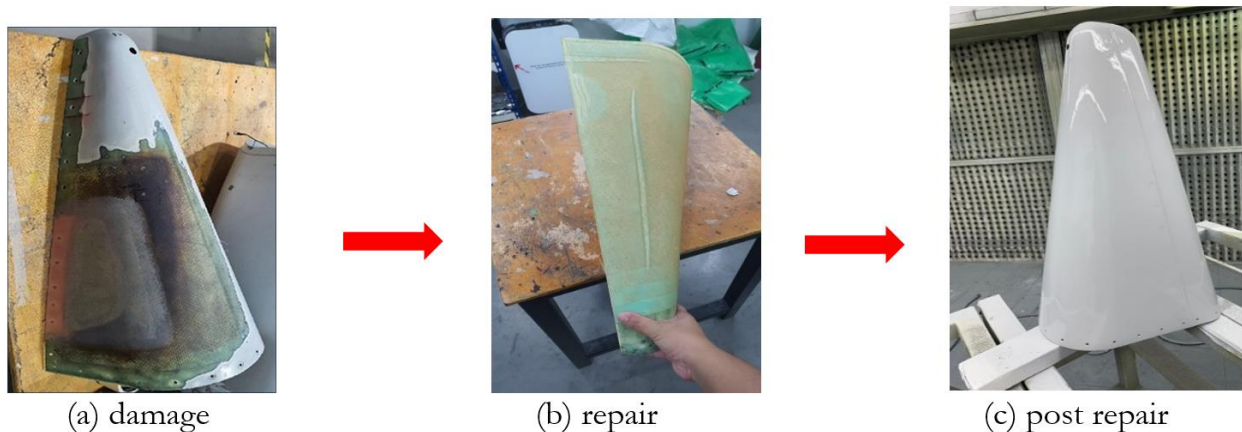
Figure 7 shows the curing cycle during the process. The actual and estimated curing cycles show a good argument within the boundaries result. Therefore, the process is valid and in accordance with the desired perimeter. Once the vacuum bag system is separated from the part, crevices due to resin ridge presence on the outer surface of the part can be observed as shown in Figure 7. This line is caused by the wrinkling of the peel ply and it does not dislocate the fiber. A sanding process is later carried out to smoothen the surface. Dimension-wise, the component is undistorted due to the mold holding on its position from the surrounding pressure exerted on the surface. Finally, the tap test is carried out at the locality of the repair cured area. Neither disbonding nor delamination is found to be present within the component. Overall, the process shows positive result and the component is proceeded for painting.

Figure 7: The repair process from damaged, repaired and post-repaired
