A CASE STUDY OF AIRCRAFT COMPOSITE COMPONENT REPAIR UTILIZING AUTOCLAVE CURING

Abstract: This paper presents the evaluation process of aircraft composite component structural repair of flap fairing origin for Boeing 737-800 aircraft. The intended repair has been carried out due to a wide area of damage that requires utilization of an autoclave. All preparations are carried out in accordance to the aircraft structural repair manual of Boeing 737-800 aircraft. The damage is removed via the step cutting method on the outer surface of the component prior to the inspection verification via tap test inspection. In order to prevent profile bending and torsion, the part is placed on a male mold that will be vacuumed together. The damaged area is repaired using similar materials and orientation, but with an additional layer as per prescribed in the manual. The component is then cured inside the autoclave at 121°C for two hours at a pressure of four bars. Once cured, the component is inspected through the post-repair inspection for visual and structural integrity prior to painting. The post-repair inspection has indicated that the repair has preserved the component and it is now fit to be u

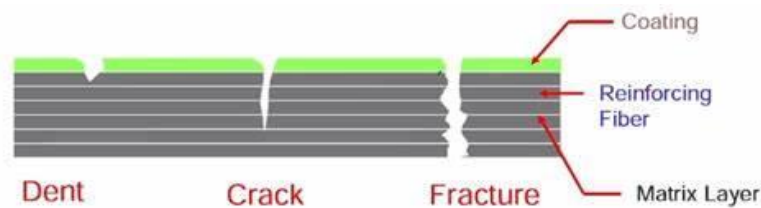
Figure 1: Typical damage on a laminated composite structure

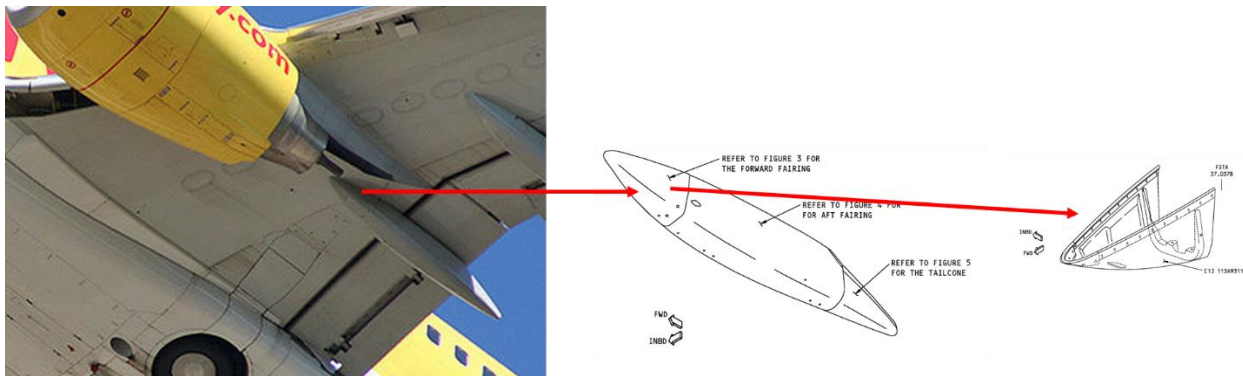
Figure 2: Location of the IFFF with respect to Boeing 737 series aircraft [11]

Upon inspecting the IFFF component, it has been found that the inboard side of the component is affected by heat damage due to its close vicinity of the exhaust area. The prolonged exposure has led to diminishing the component integrity and thus it is required to be repaired. Therefore, the objective of the task is to carry out the repair as outlined by Aircraft Structural Repair Manual (SRM) requirement. This involves utilization of the autoclave as the curing mechanism and the comparison of the outcome of curing with respect to the post-repair inspection. In short, the damage is evaluated in accordance to the corresponding SRM [10] and upon evaluation, the area subjected to damage is found to be repairable as documented in the SRM. Damage due crack has been found at the rear section of the component. It has been suggested that a major repair need to be carried out due to the fiber damage and the damage size. A preliminary evaluation is carried out to determine the extent of the damage through both physical and non-destructive testing. The damaged component is shown in Figure 3.

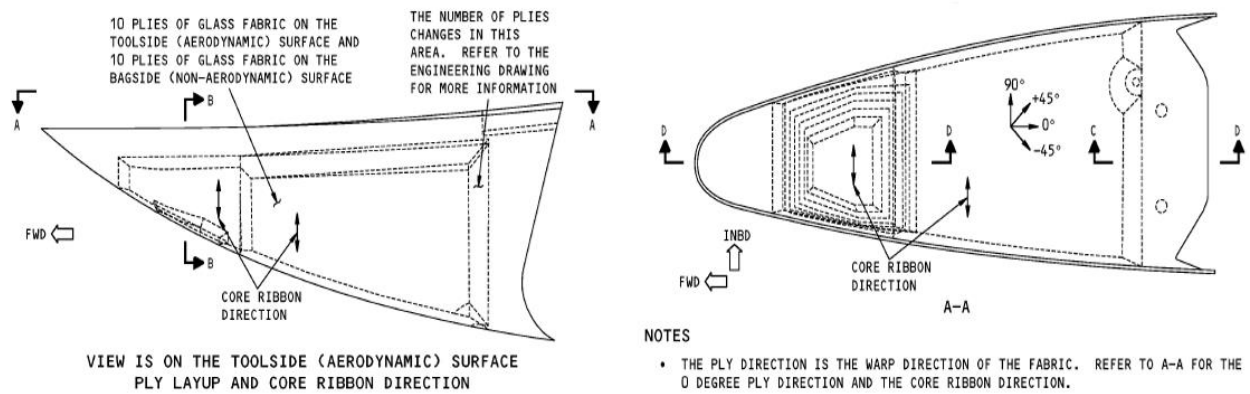
Figure 4: Information pertaining to the component configuration [11]

Furthermore, assessment from non-destructive testing has indicated that the damage is feasible to be repaired. However, due to its size characteristic, autoclave curing has been suggested for the curing of the component. This is to ensure the compaction from the pressure can assist in consolidating the repaired plies and subsequently provide a stronger and intact bonding between the original and repair layers. Further information is retrieved pertaining to related material specification and curing parameter. Figure 4 shows the configuration of the component. Upon investigation, P1 to P10 have been removed in order to go for the preparation process. Once the damaged plies have been removed, a male mold is fabricated using layer of fiberglass laminates saturated with high temperature curing resin in preparation for autoclave curing. Six layers of 400 gsm woven roving fiber glass are used, which lead to an average thickness of approximately 8 mm as depicted in Figure 5. It should be noted that the use of the male mold is to provide a positive pressure and reduce distortion whilst curing.
